ARL-TR-8019 • MAY 2017

Sensing Applied Load and Damage Effects in Composites with Nondestructive Techniques

**by Colleen Rosania, Mulugeta A Haile, Natasha C Bradley,
Asha Hall, Michael Coatney, and Fu-Kuo Chang**

Vehicle Technology Directorate, ARL

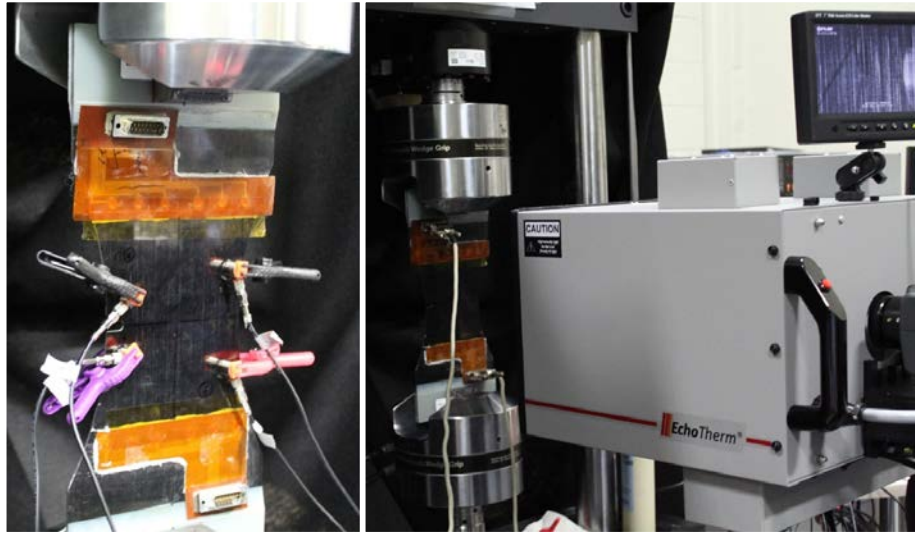
Fig. 6 Photographs showing a composite sample loaded for testing with AE sensors (left) and the thermographic imager and cables attached for ScanSentry data collection (right)

At each data collection point Lamb waves were propagated from each actuator to each sensor, adding up to a total of 36 paths of information to analyze for each actuation frequency at each time point. The actuation signal was a 5-peak Hanning-windowed tone burst signal with a center frequency ranging from 150 to 450 kHz. The average input voltage for each signal was 50 V and the average gain was 20 dB, though actuation parameters were varied for each actuator-sensor event such that the amplitude of the sensed signal was approximately 0.8 V to avoid saturating the sensing system. To choose and verify the wave modes present from these propagation signals, dispersion curves for these composite plates were computed using Disperse software (by Dr Cecilia Wilson). When these actuation frequencies were used, data with distinguishable fundamental symmetric and antisymmetric modes were collected. The testing apparatus is shown in Fig. 6.

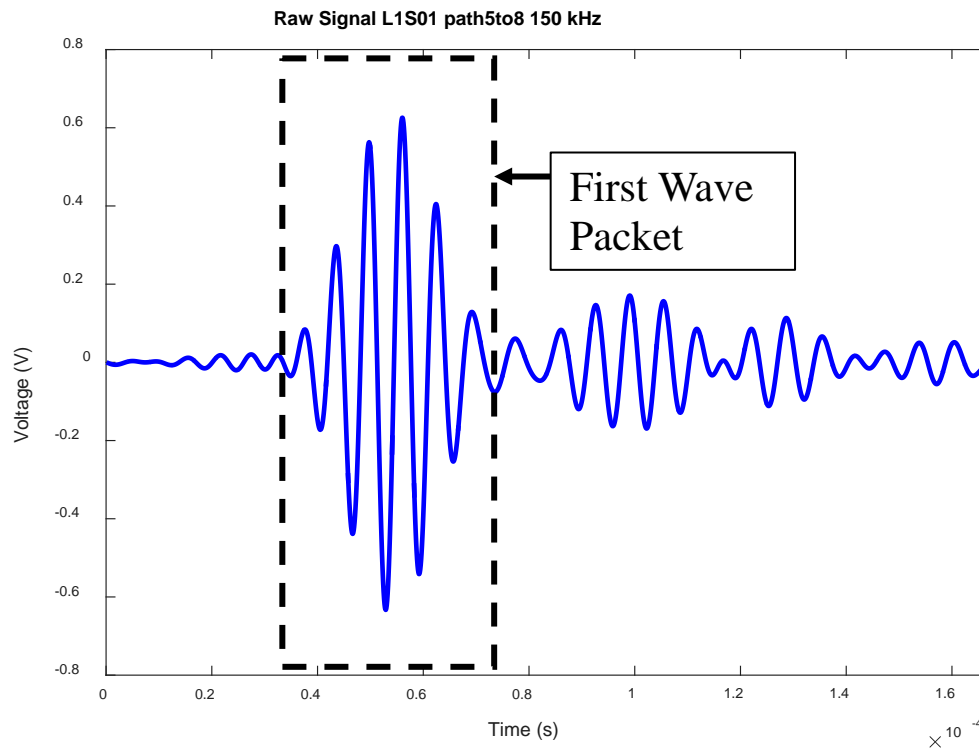
Fig. 11 Example of the raw signal and the windowed first wave packet from L1S01 path 4to9 150-kHz actuation frequency

Based on initial raw data analysis and dispersion curves created pre-experiment, the most consistently clear wave packet was the first arrival, the S_0 mode. Figure 11 shows an example of the sensed signal from an actuator-sensor pair with the actuation frequency of 150 kHz. In each data set, the first arriving wave packet is identified, as shown in Fig. 11, and analyzed for signal parameters in the time and frequency domains. Figure 12 shows the amplitude (A) and time of flight (TOF) were studied in the time domain and are extracted from the window enclosing the first arriving wave packet.

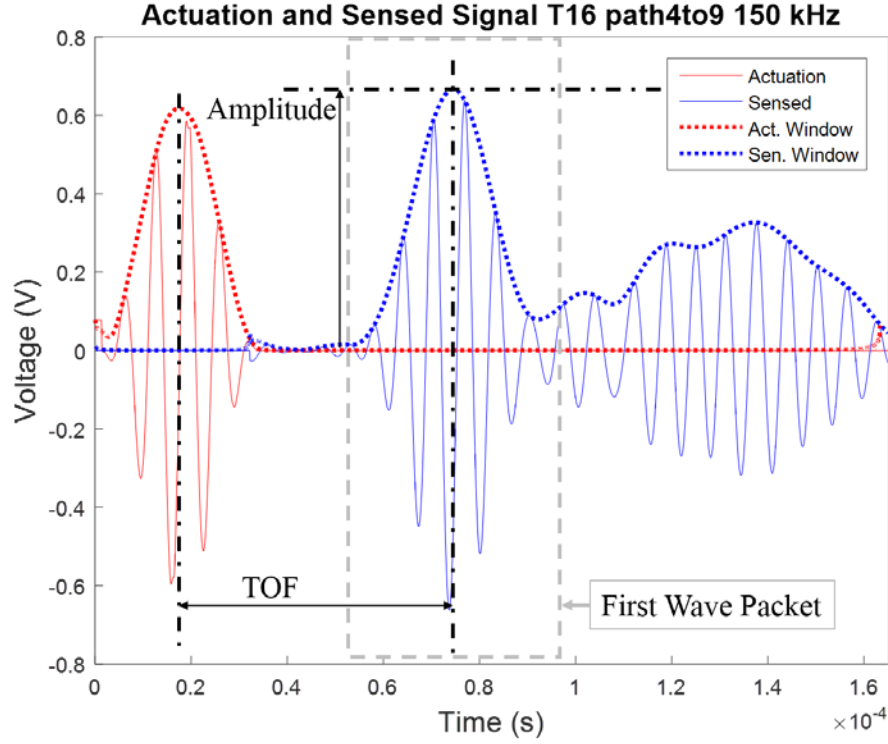
Fig. 12 Example of how the time domain features of TOF and amplitude are calculated from the sensed signal by using the envelopes of the waveforms path 4to9 150-kHz actuation frequency

The amplitude relates to the amount of displacement caused by the propagating Lamb wave and is complexly related to the structural properties and attenuation caused by the material. Signal amplitude changes were extracted using Eq. 1, where s is the sensed signal and H is the Hilbert transform, which finds the envelope of the signal

TOF is the measure of the length of time taken by an actuation signal to reach a sensor. The TOF gives a sense of the Lamb wave velocity, which is related to the material properties of the composite. The TOF calculation is given in Eq. 2 where a is the actuation signal and t is elapsed time.

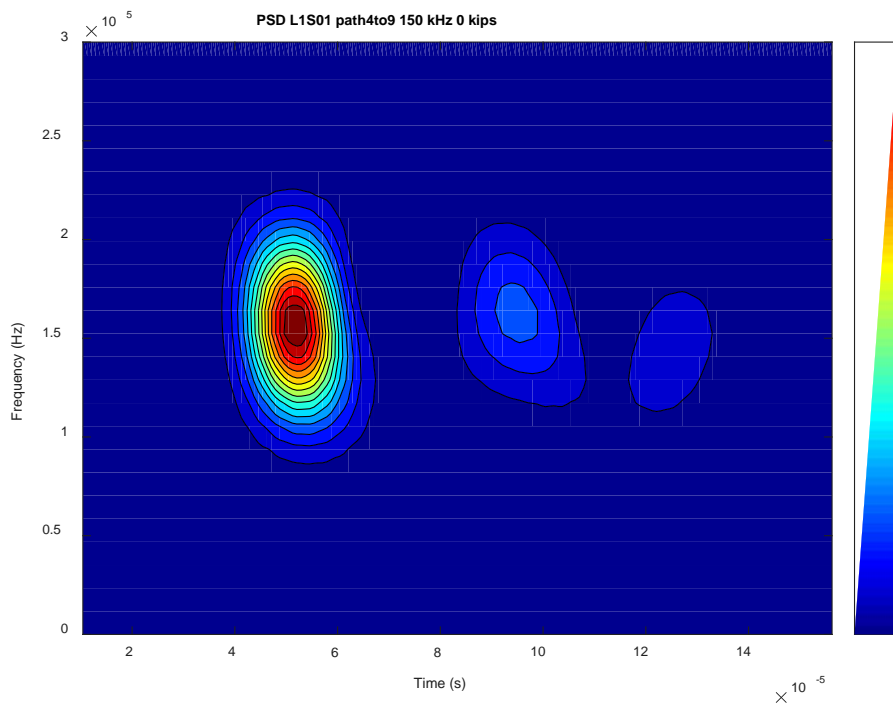
Fig. 13 Example of the PSD of L1S01 path 4to9 150-kHz actuation under a 0-kips load

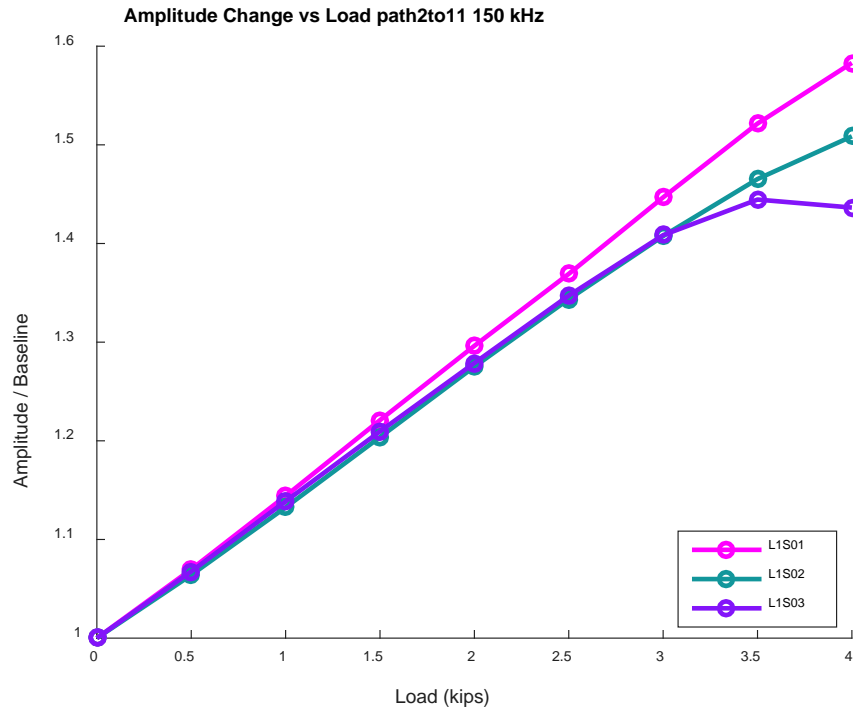
Fig. 17 Normalized amplitude change in the first wave packet of data with actuation frequency 150 kHz from path 2to11 for ARL-tested coupons

Signal features that have been found to be most influenced by applied load are those described in the previous section: amplitude, maximum PSD value, and signal energy. Time of flight is also influenced by applied load, but less consistently than these other signal features. Plots showing the change in these 4 features (normalized to the baseline value for each coupon) as increased load is applied are shown for each straight path: amplitude of path 2to11 in Fig. 17, TOF of path 5to8 in Fig. 18, maximum PSD of path 3to10 in Fig. 19, and energy of path 4to9 in Fig. 20.

Figures 17, 19, and 20 show that above 3 kips load inflection points begin to appear in the data—this is indicative of damage initiation and progression. Based on Figs. 17–20 and similar plots from other paths and actuation frequencies, X-ray images taken after the initial loading cycle, and notes about audible cracking during tests, it can be hypothesized that matrix cracking can begin in a sample between 2.5- and 4-kips load. By filtering out data beyond these inflection points (based on the hypothesis that they are also affected by damage), Lamb wave data influenced only by applied load can be isolated. This will be done when creating modeling strategies to predict applied load from ultrasonic data, as only data with applied load influences and not those from the combined influences of applied load and data should be used for this inverse problem.

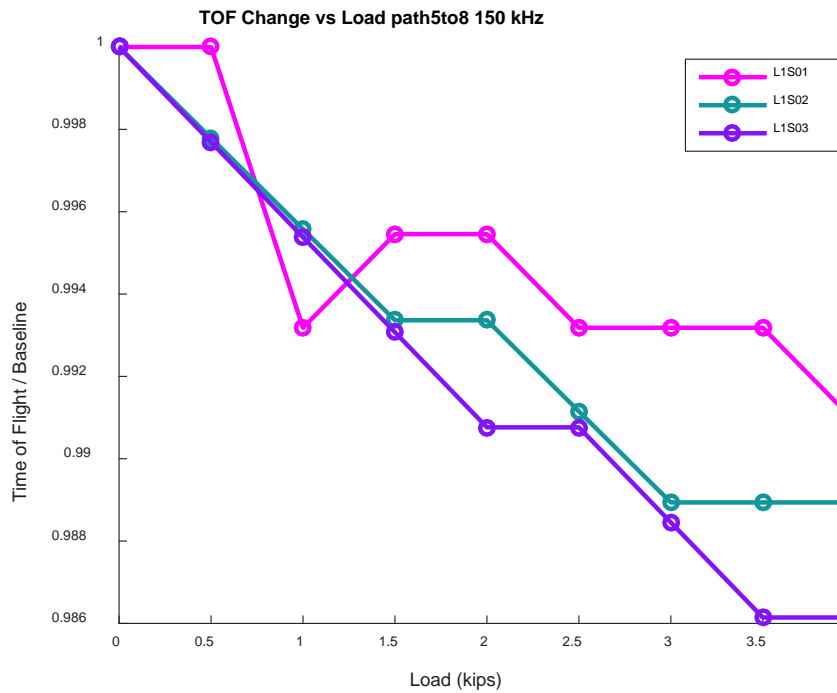
Fig. 18 Normalized TOF change in the first wave packet of data with actuation frequency 150 kHz from path 5to8

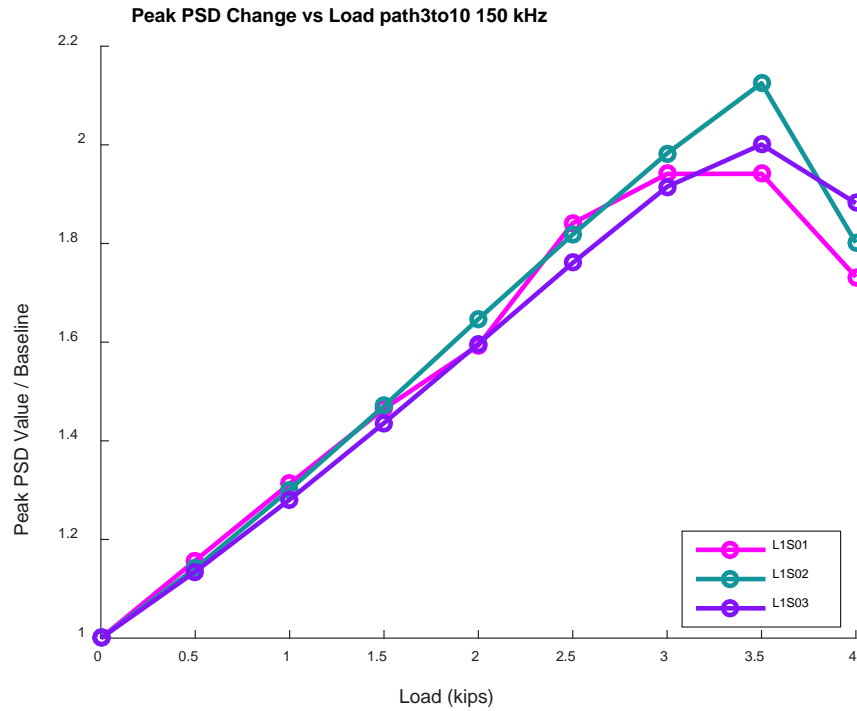
Fig. 19 Normalized maximum PSD value change in the first wave packet of data with actuation frequency 150 kHz from path 3to10

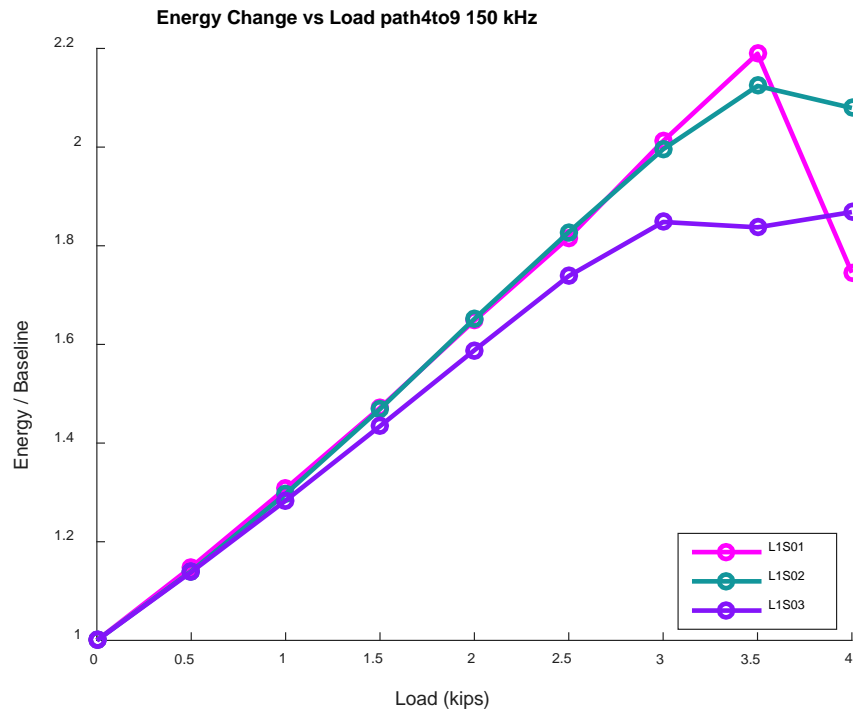
Fig. 20 Normalized energy change in the first wave packet of data with actuation frequency 150 kHz from path 4to9
